# Floor Plan

712 Main Street  
Culdesac, ID 83524

# Restroom Renovation Saddle Club

Job Number:  
14-022  
Date:  
07-07-14

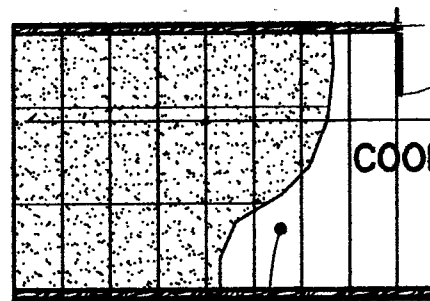
# Roof Framing Plan

3/4" PLYWOOD  
DECK'G

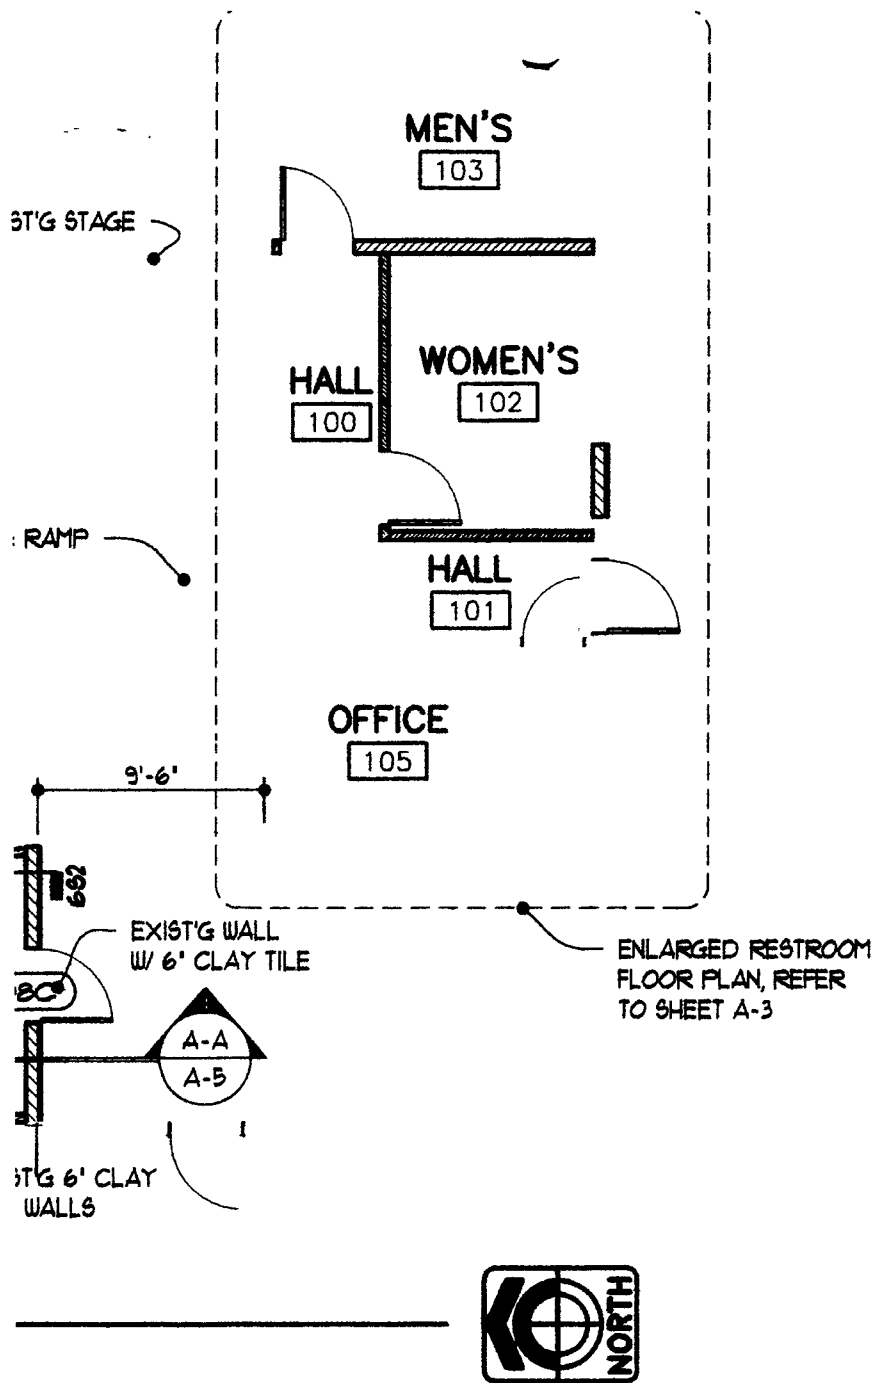
PROVIDE SIGN WITH 1"  
LETTERS 'THIS DOOR TO REMAIN  
UNLOCKED WHEN BUILDING IS  
OCCUPIED'

OCCUPANT LOAD  
(1,110 / 15 = 118)

OCCUPANT LOAD  
(231 / 200 = 3)

EXIST'G WALL  
W/ 6" CLAY TILE

EXIST'G CONC  
FLOOR

2x4 FURR'G &  
SUPPORT WALL  
EXIST'G DOOR
